NARROWING THE PATH

lan Giammanco and Brenna Meisenzahl

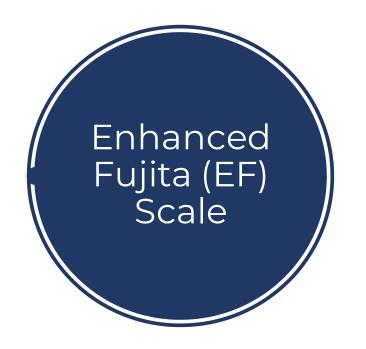
A rotating column of air, in contact with the surface, pendant from a cumuliform cloud, and often visible as a funnel cloud and/or circulating debris/dust at the ground.

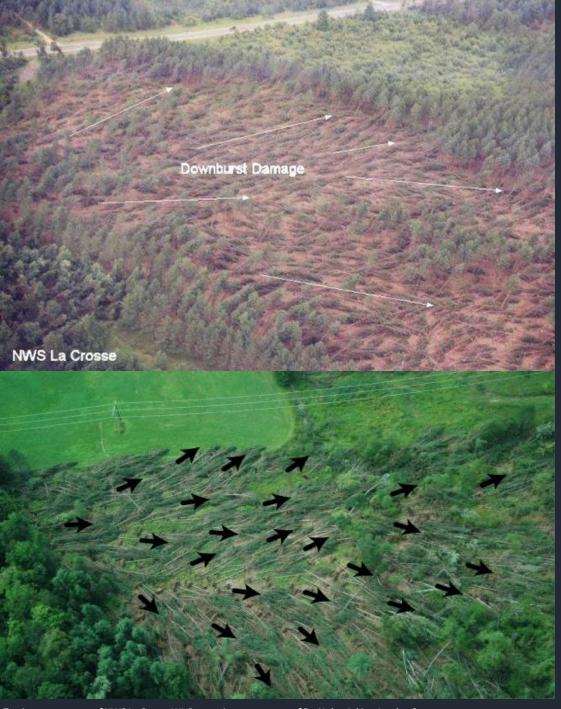
Downburst & Microburst Damage Patterns

- Particularly strong downdrafts from thunderstorms
- Diverging damage pattern
- Surface wind gusts can reach 100+ mph
- Damage can be mistaken for tornado
- Hazardous for aircraft
- Very local and short lived

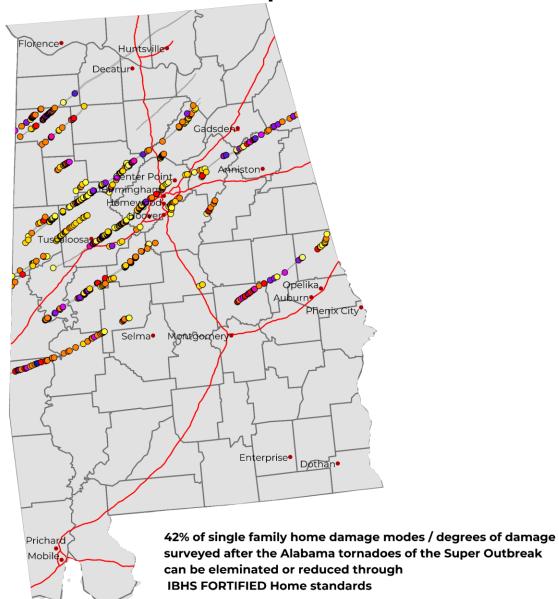
Degree of Damage

- O Surveyed but no visible damage
- Visible damage threshold

Protects against water

Roof cover damage < 20%

Broken windows and/or

Significant roof cover loss, damage to garage doors, carport/porch roof structural damage

House shifted on foundation

- Roof structural damage, walls remain intact
- Exterior wall failure
- Most walls on lowest floor collapse
- All walls collapsed
- Complete destruction, slab swept clean
